# Getting More From Your Intelligent Pig Inspection

Roland Palmer-Jones, Prof. Phil Hopkins, and Andre Goncalves

Penspen Integrity

PPSA Seminar  
Aberdeen  
14 – Nov 2007

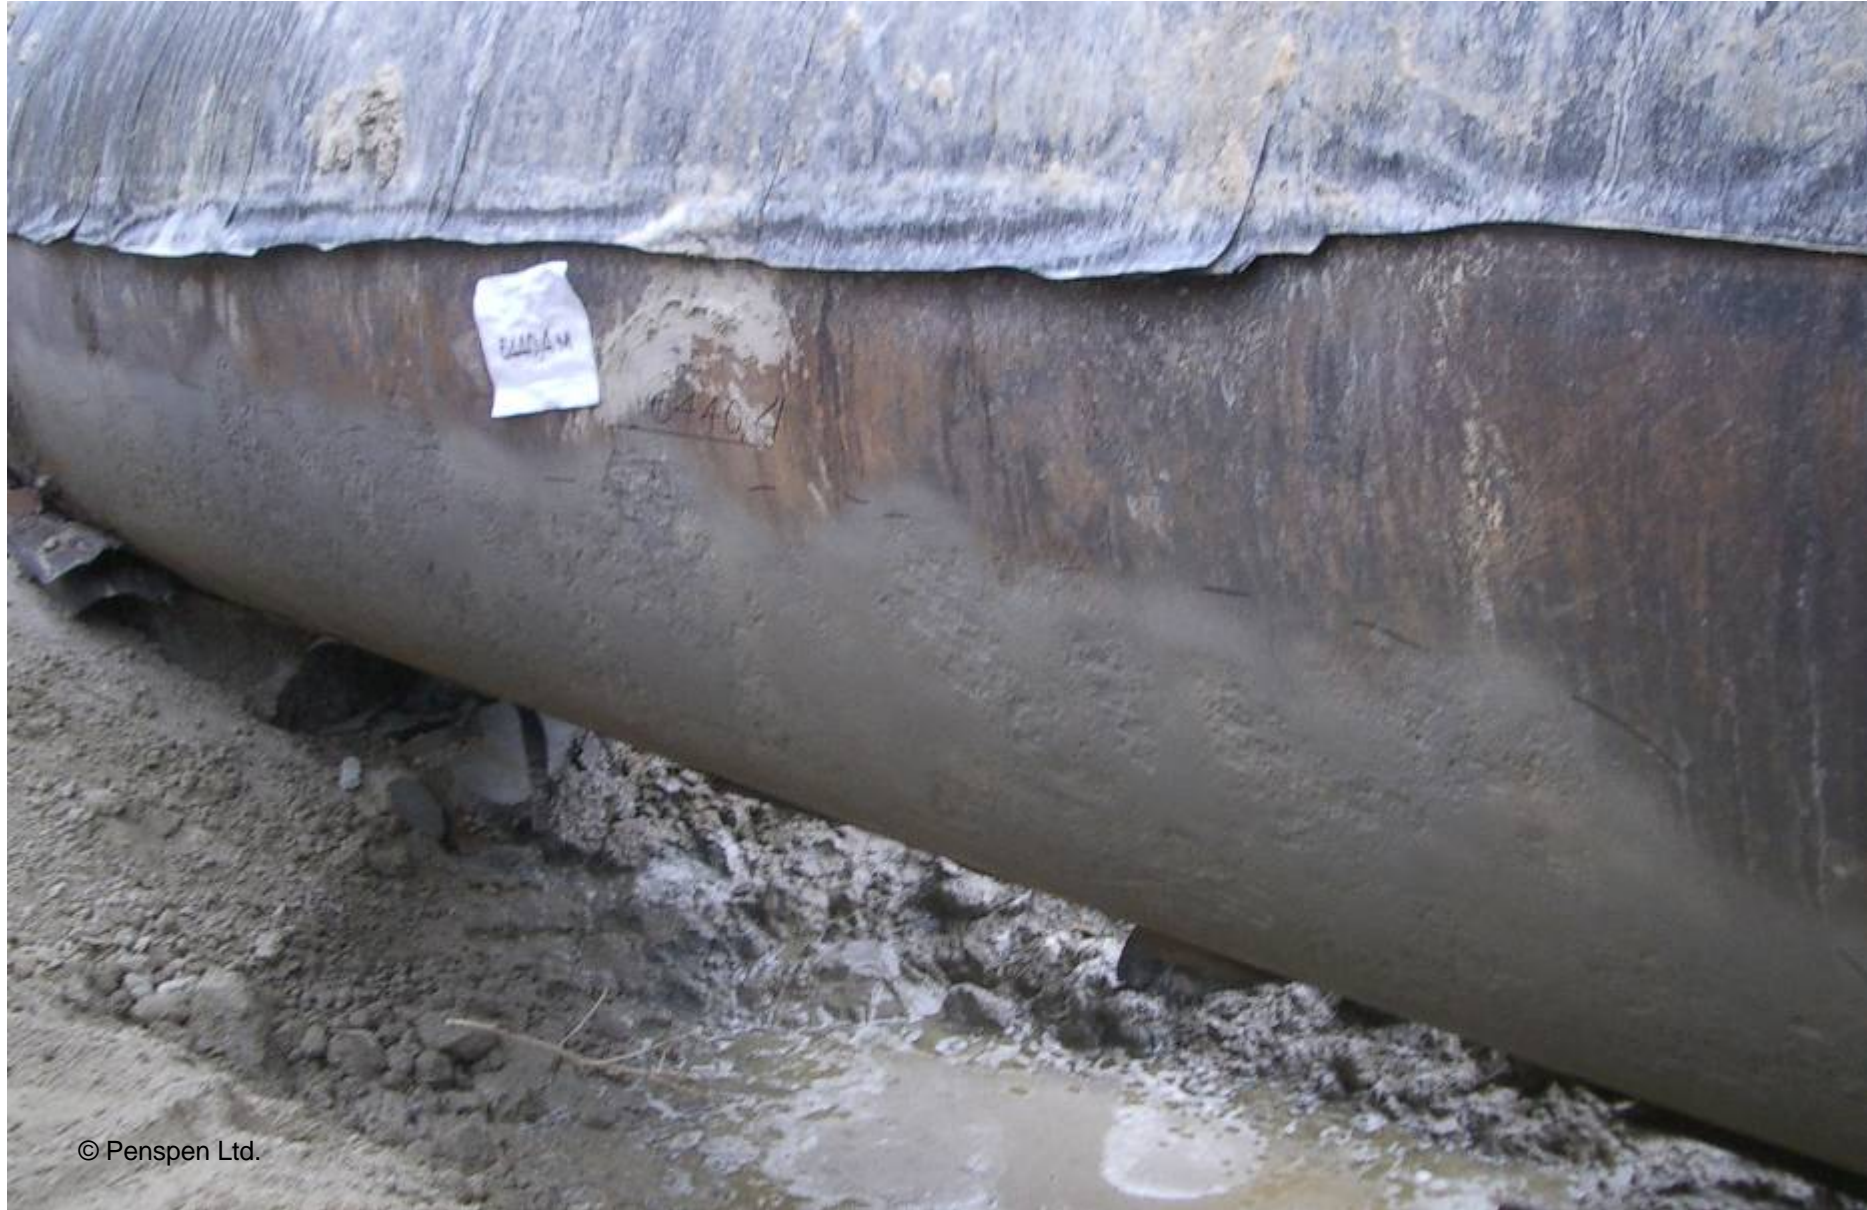
# Multiple Defects?

26% (13.5 len x 14.0 wid)

Metal Loss

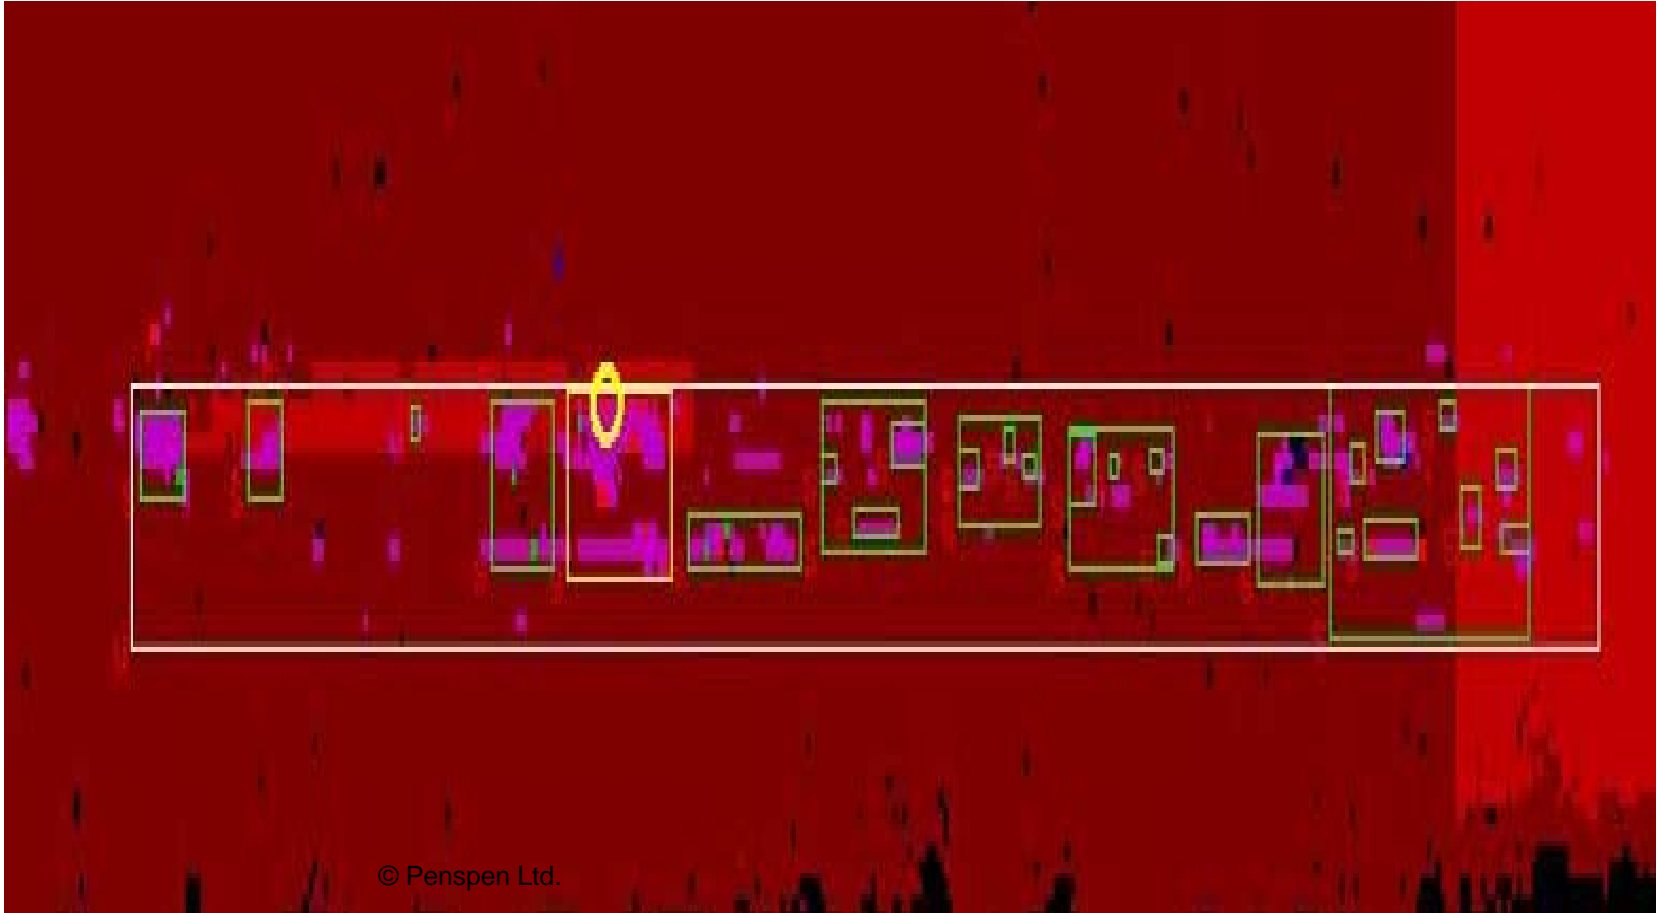
# UT data

# Example 1

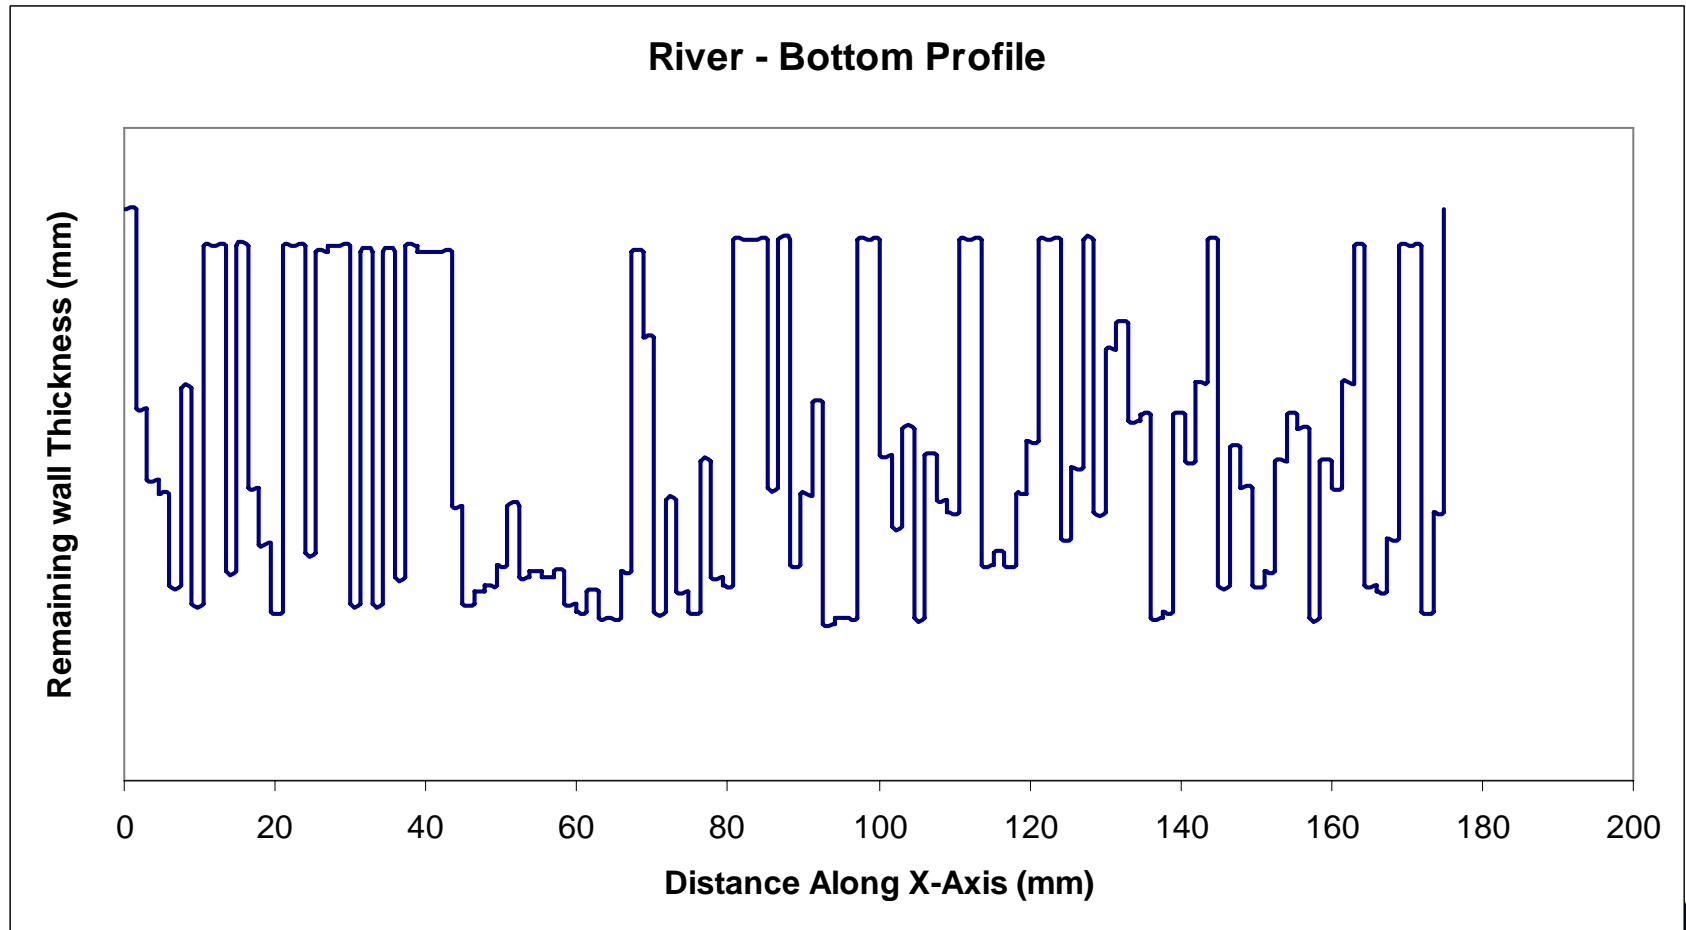
# Riverbottom Profile

## Failure Pressure 305 bar

<b>Assessment</b>	<b>Data</b>	<b>Maximum Reported Depth (%t)</b>	<b>Length (mm)</b>	<b>Defect Profile</b>	<b>Failure Pressure (Bar)</b>
Standard	MFL pig 'Cluster'	63	330	Rectangular	53
Expert	MFL pig 'Boxes'	63	330	'River-Bottom'	113
Expert	External UT	50.5	1760	'River-Bottom'	85
